NASA-CR-159622  
LYC 79-25

**FINAL REPORT**

**DEVELOPMENT OF SPIRAL-GROOVE  
SELF-ACTING SEALS FOR  
HELICOPTER ENGINES**

**AVCO LYCOMING DIVISION**

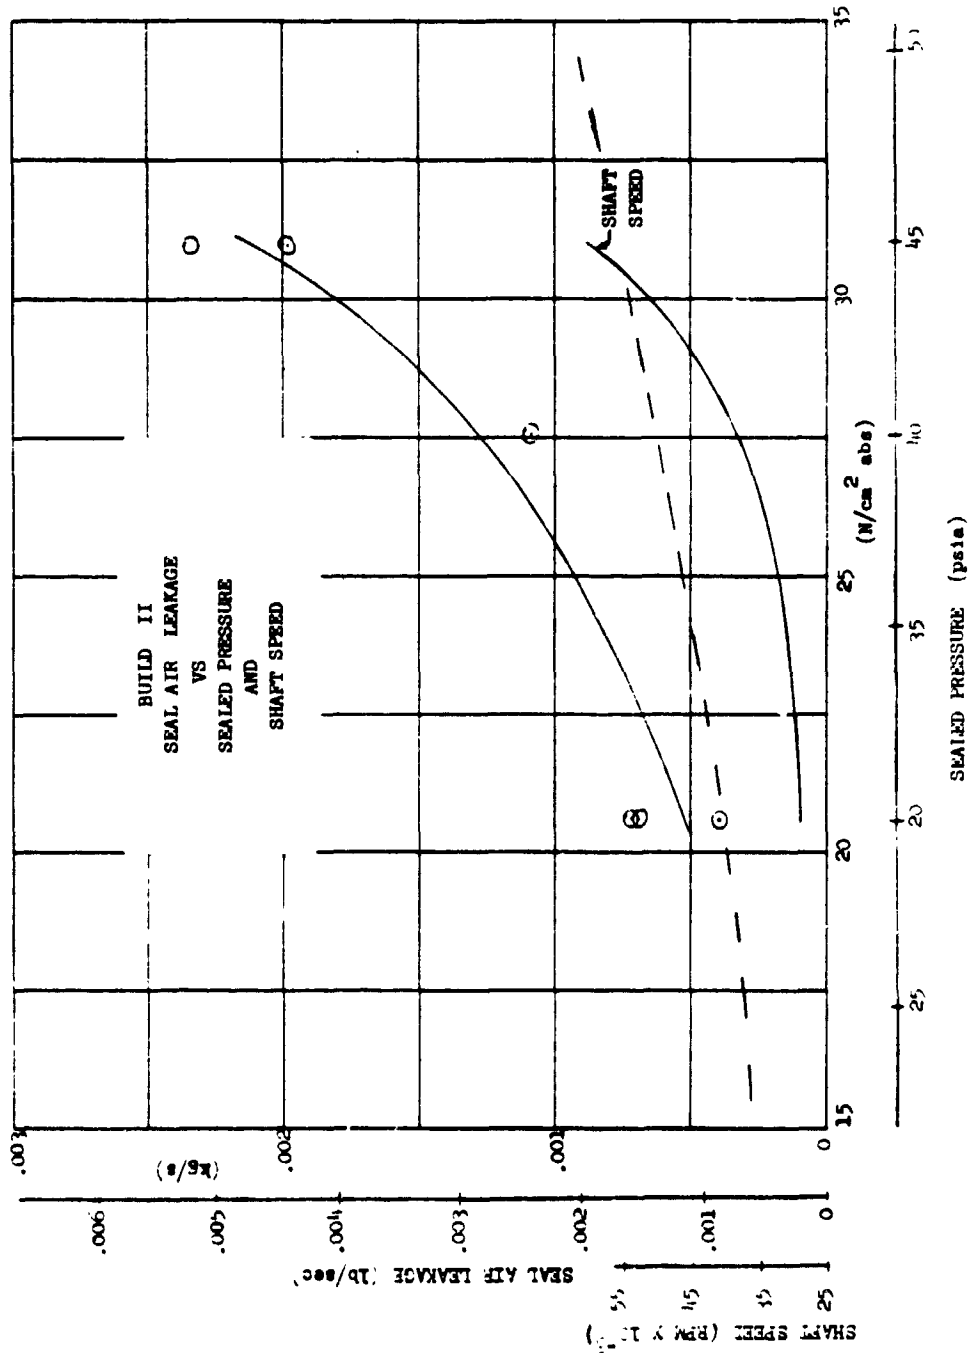
Figure 17. Air Leakage for Runs 1 Through 15.

Seal Air Leakage - Air leakage measurements throughout this and subsequent phases of the test program were impaired due to a marginal operating clearance between the primary sealing element and the seal housing. This was due to a combination of the reduction of the existing clearance due to press fit deflections of the seal housing which resulted from installation into the test rig and also the deflections caused by exposure to the various pressures and temperatures of the test points. Although no binding occurred at assembly, further deflections apparently resulting from the operating conditions were sufficient to cause intermittent binding of the primary sealing element during testing. Often, a low and high leakage characteristic were observed at a particular test point. On all air leakage plots, an estimated air leakage characteristic is presented (dashed line) along with actual data points. Data groups with significantly varying leakage rates for a specific operating condition are tabulated in Table 3, but are not plotted. Air leakage results from this phase of testing are presented in Figure 17.

The overall reduction of the length of the primary sealing element was not significant, but the magnitude of variations in the local surface increase significantly. An increase in leakage rate was observed after the sixth run. This can be due to either changes in seal pressure distribution resulting from the surface variation or the tendency of sealing element to bind, as previously described. Because of this, air leakage rates are high considering the sealed pressure levels tested.

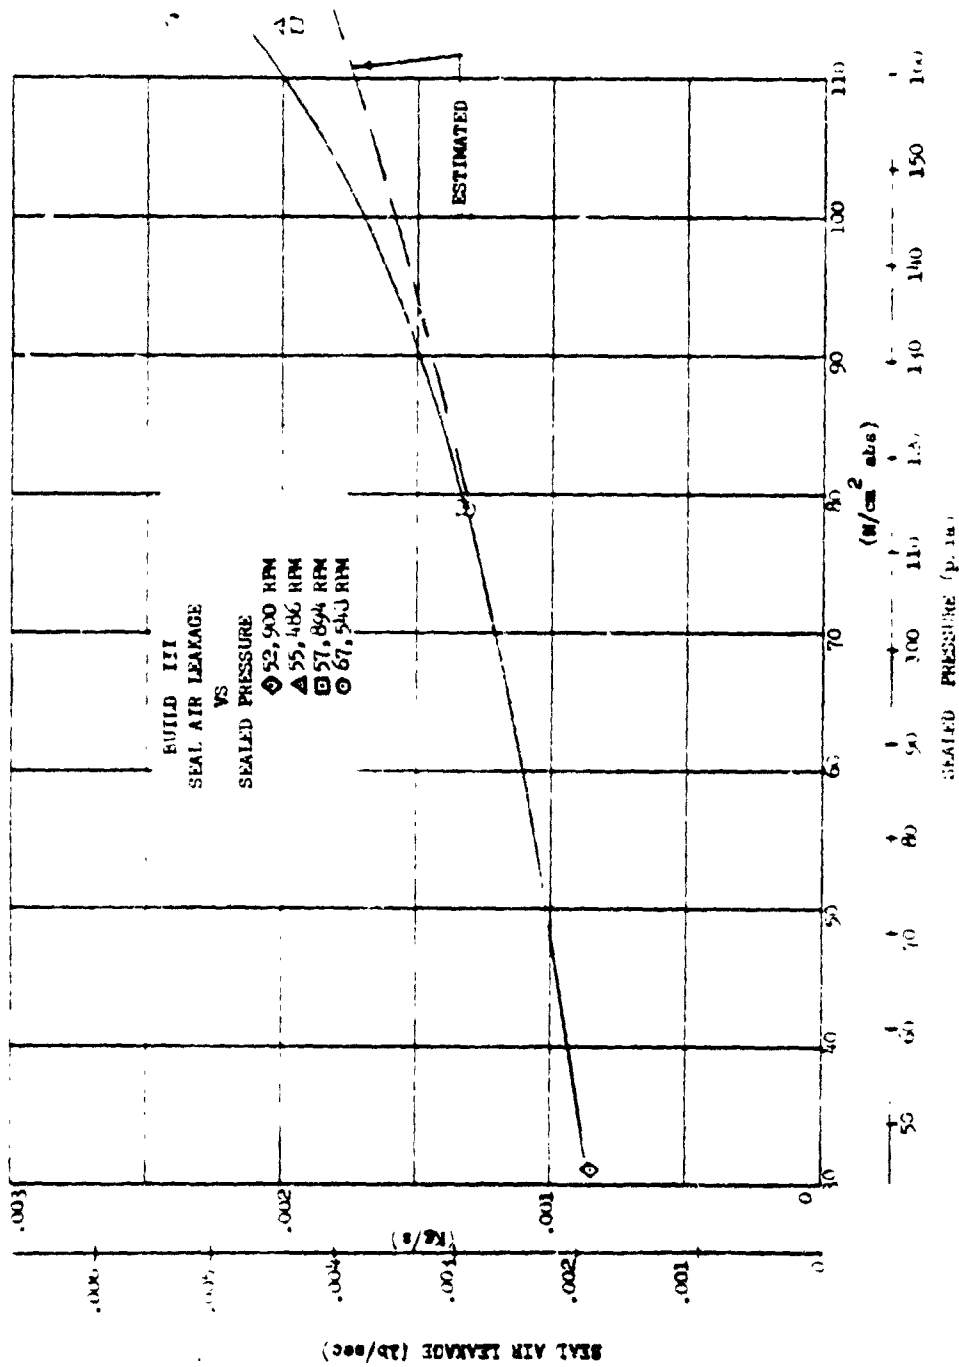
Figure 20. Air Leakage for Runs 16-22.

Seal Air Leakage - Air leakage data is presented in Figure 20, along with the balance of the data accumulated during the remainder of the endurance test (Build IV). Endurance test results are discussed at the completion of Build IV testing.
